SUBJECT: Operational Report - Lessons Learned, Headquarters, 520th
Transportation Battalion, Period Ending 31 July 1970 (U)

DEPARTMENT OF THE ARMY
HEADQUARTERS, 520TH TRANSPORTATION BATTALION (AM&S) (GS)
APO 96289

SUBJECT: Operational Report - Lessons Learned 520th Transportation Battalion
(AM&S) (GS) Period Ending 31 July 1970, RCS CSFOR-65 (R2)

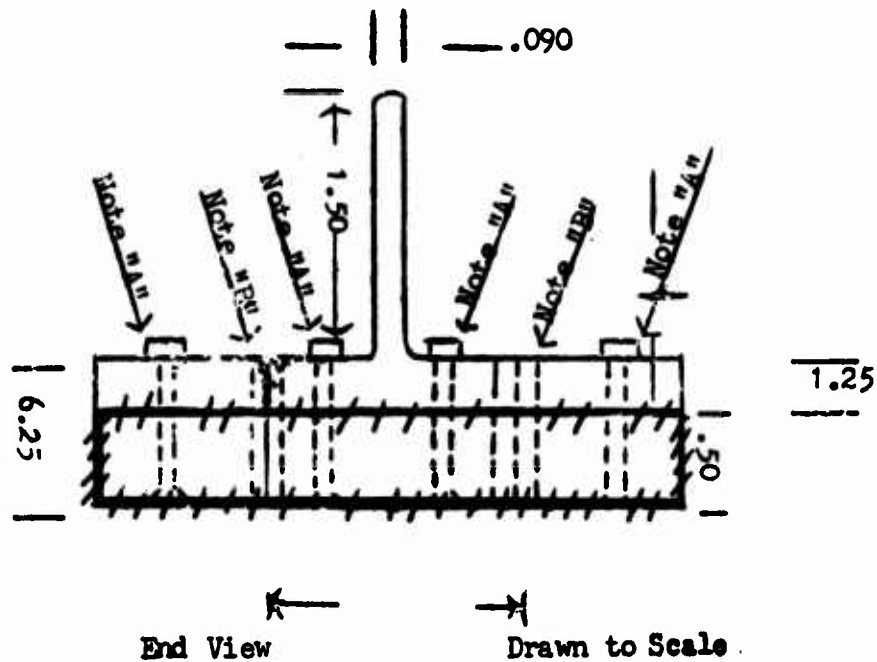
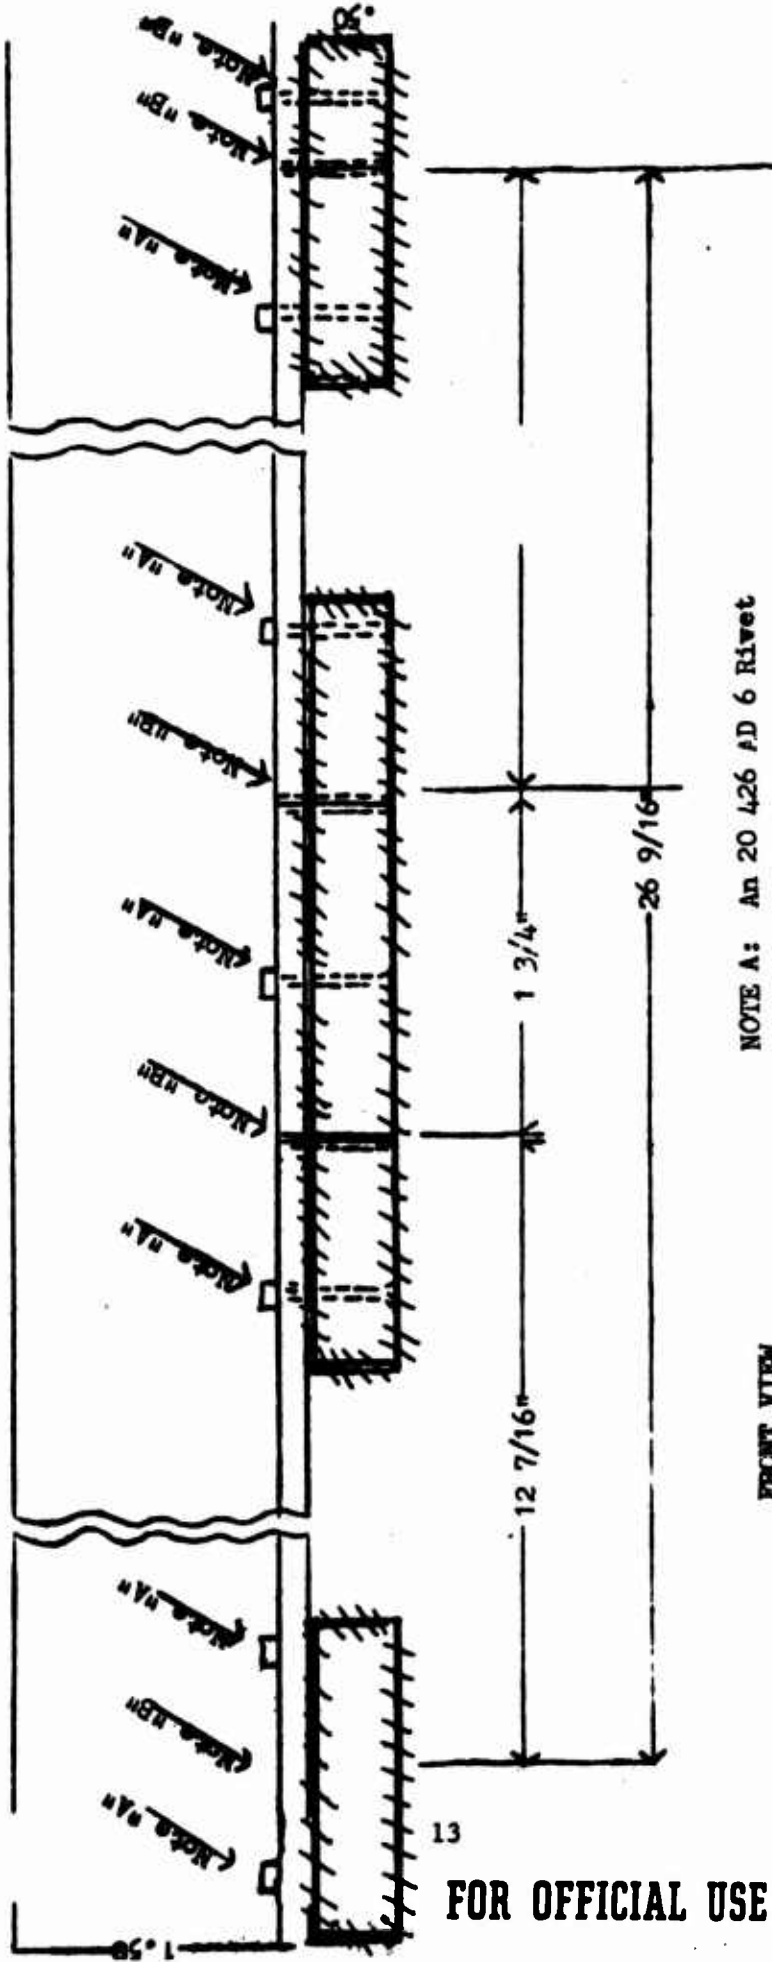
ILLUSTRATION .1

(a) Observation: A locating tool for drilling mounting holes in new center engine decks on UH-1D and H model aircraft should be mounted to the deck to insure proper alignment of the fixture holes. (Incl-1a, 1b)

(b) Evaluation: This tool is used on the inboard leg of the tripod engine mount assembly. It is mounted transversely to the engine deck and
INCL

bolted to the deck using the right and left rear engine mounting holes located at station 200, LBL13 and RBL13. The center engine mount bolt holes are then drilled using a 1/4" bit. The fixing tool is then removed, and proper installation of the center engine deck can be completed.

The areas outlined in red are $\frac{1}{2}$ inch spacers rivited to the "T" extrusions to provide clearance for the drain channels mounted on the engine deck.

(c) Recommendation: That the above stated procedures be included as a part of the appropriate TM. A DA Form 2028 has been submitted.

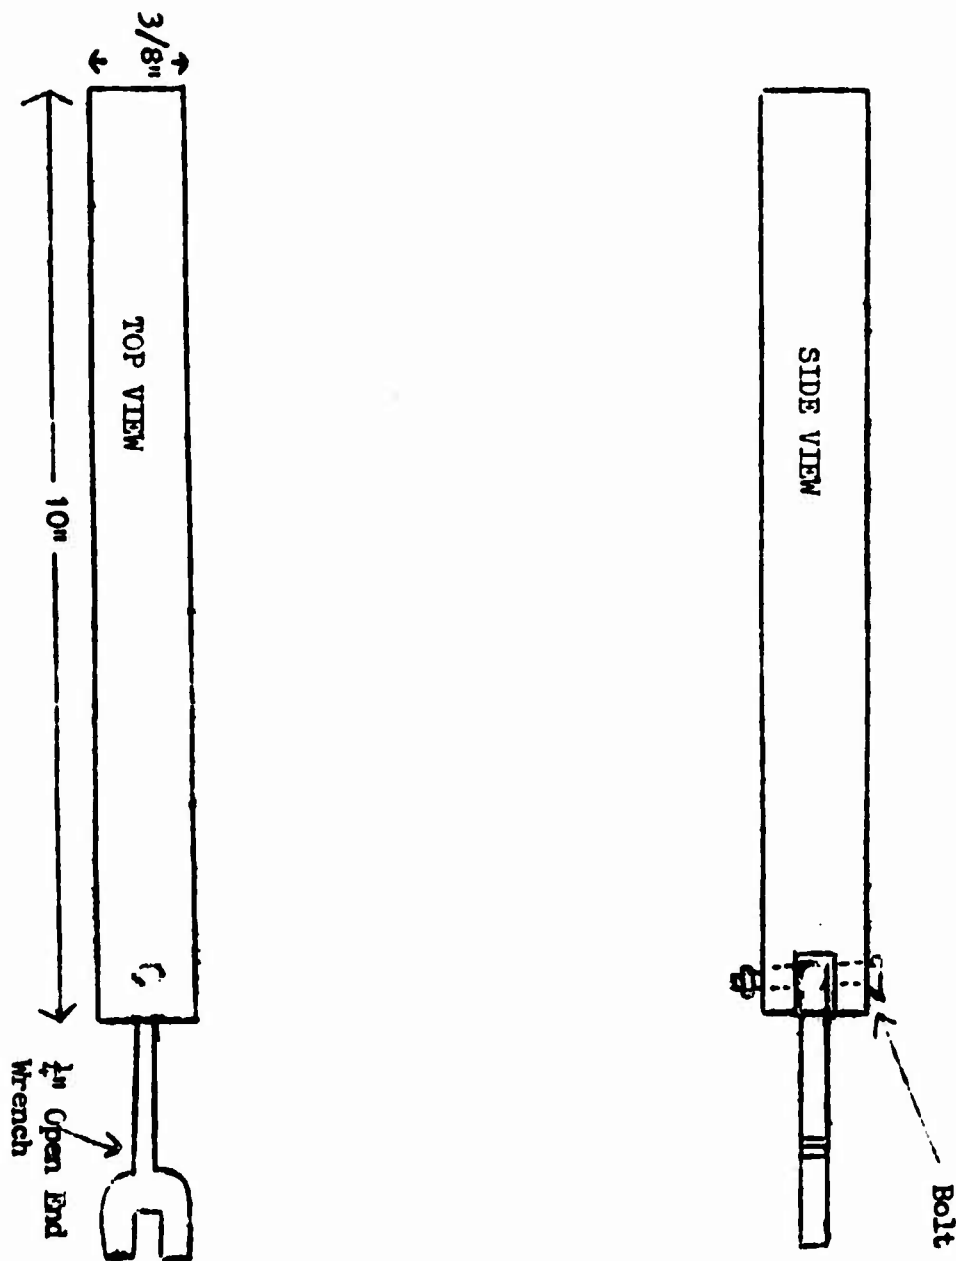
Inst-2

(a) Observation: The special tool (FSN 5120-763-7565, PN 6798292) for adjusting the idle speed on the T63-A and T63-5A Allison engine is not always available.

(b) Evaluation: The special tool listed above may be locally manufactured from a piece of 3/8" round stock cut 10" long and a 1/4" open wrench. Cut the 1/4" open end wrench in half. Slot one end of the 3/8" stock to accept the cut end of the 1/4" wrench and drill a hole through both the stock and wrench. Secure the wrench to the stock with a nut and bolt. (Incl-2). To allow for proper movement insure that the wrench can move freely from side to side.

Adjustment tool for OH-58A idle speed.

(c) Recommendation: That units requiring this tool have their machine shops manufacture a sufficient number to meet their work requirements.
